The acoustical improvement of historic monuments: Saint Joseph Chapel, a case study

Communication prononcée à l'**ISRA, International Symposium on Room Acoustics** (Seville, Spain, September 10-12, 2007)

THE ACOUSTICAL IMPROVEMENT OF HISTORIC MONUMENTS
SAINT JOSEPH CHAPEL - A CASE-STUDY

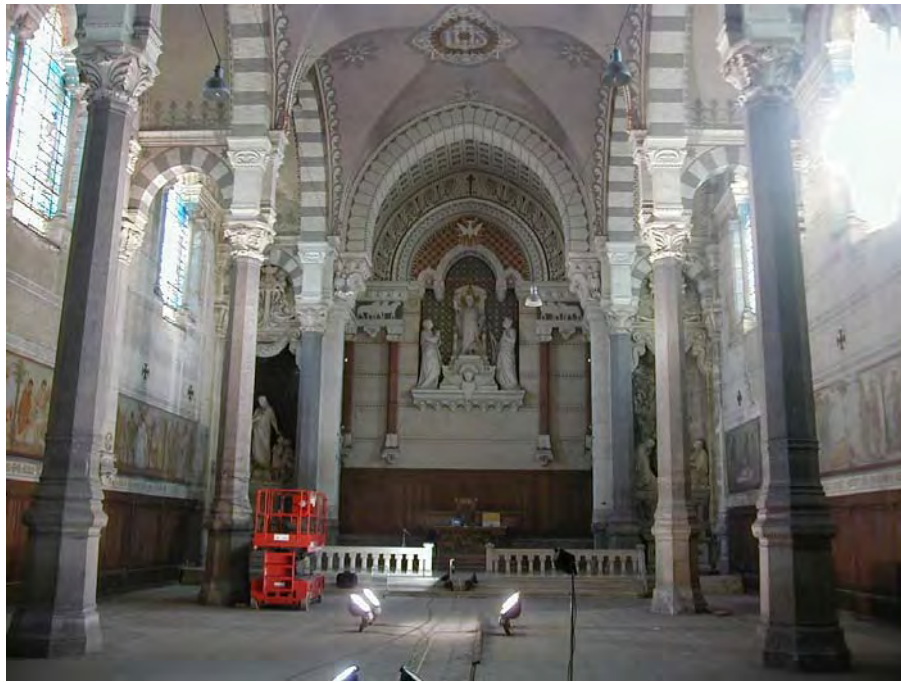
Figure 1.- Front view of the chapel

The chapel has a surface about 500 m² with an estimated volume of 8100 m³. Its roof has an average height of 15 m. The nave is 30.50 m long and 16.50 m wide including an aisle on each side. The choir is 5 m long and 9 m wide. The roof is covered with painted plaster and has several arches above the aisles. The chapel is ornately decorated with painted and sculptured motifs. Woodwork has been installed on the lower part of the side walls. The Stations of the Cross are composed of painted fabric which has been mounted on the walls (see Fig. 1 and 2).
